**TRIBUTARIES OF THE SANTA YNEZ RIVER  
BELOW BRADBURY DAM**

**Appendix C**

**SANTA YNEZ RIVER CONSENSUS COMMITTEE**

**SANTA YNEZ RIVER TECHNICAL ADVISORY COMMITTEE**

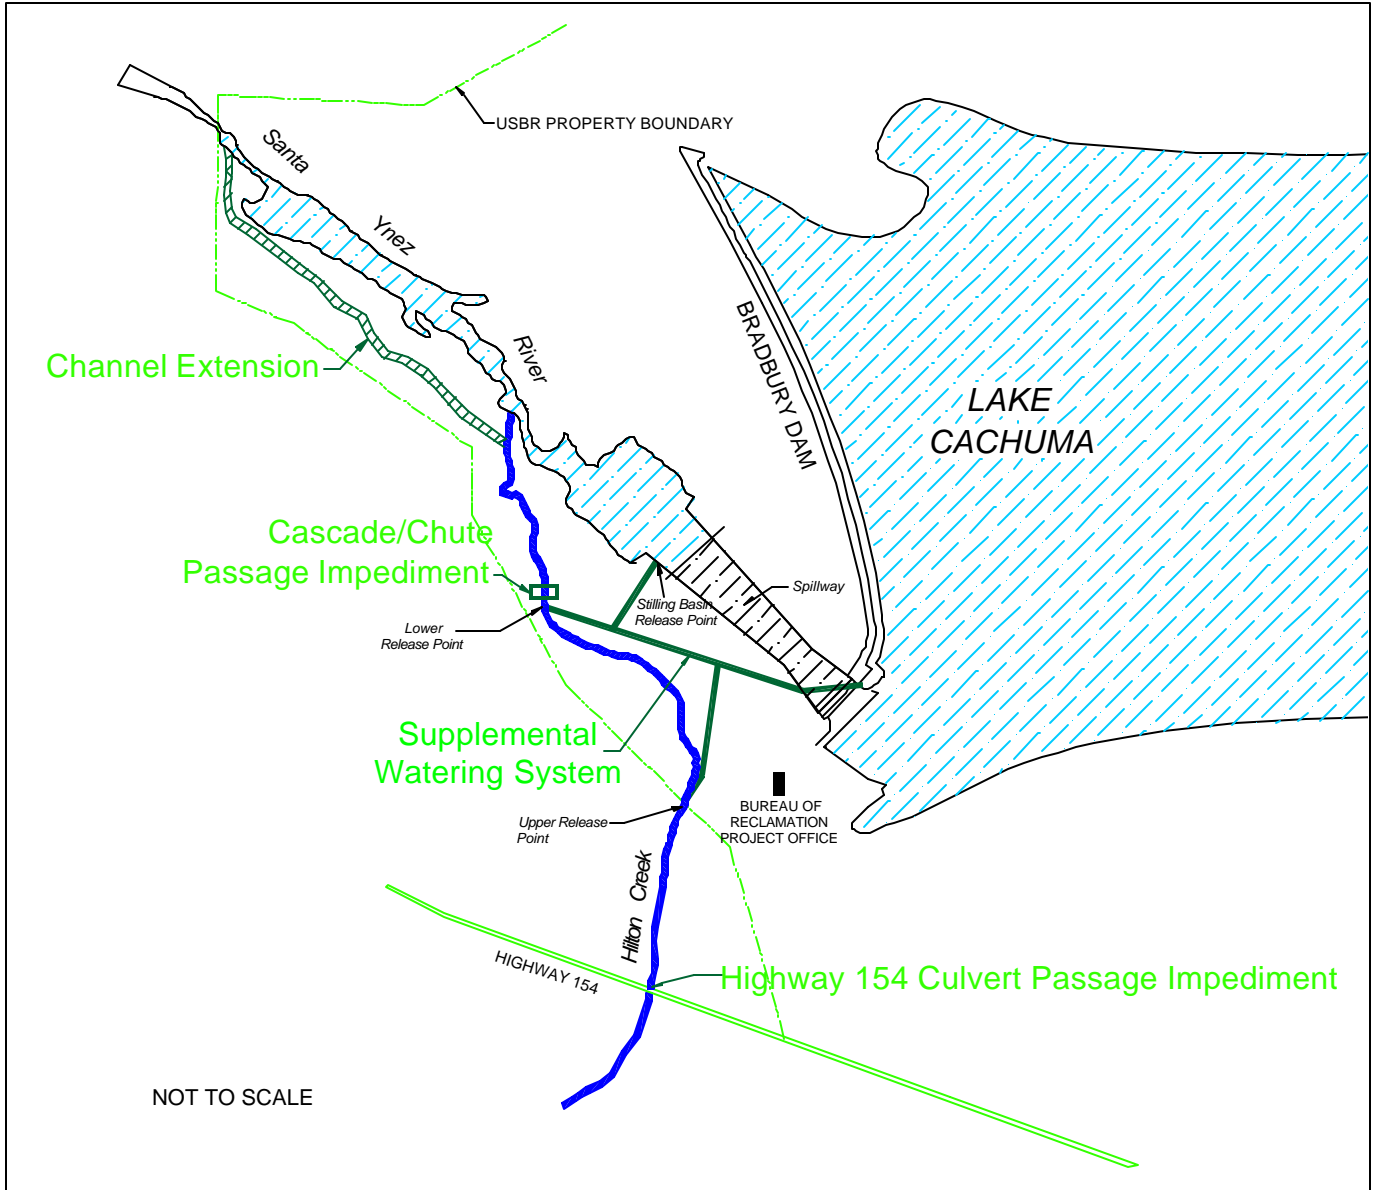
**Figure 2-1 Hilton Creek Enhancement Projects**

The lower reach of Hilton Creek is high gradient and well confined. Riparian vegetation and the walls of the incised channel shade the streambed. A rocky cascade and bedrock chute are passage impediments for migrating steelhead, located about 1,380 feet upstream from the confluence with the river. The cascade is approximately 6 feet high. A shallow pool (the “chute

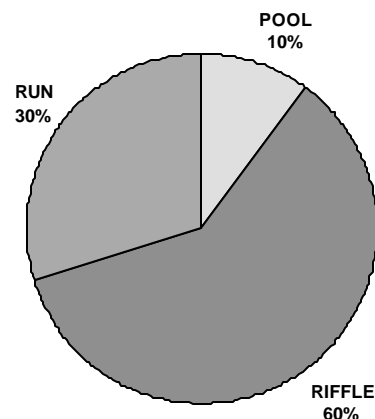
Figure 2-2 Summary of Hilton Creek Habitat Attributes

### LOWER HILTON CREEK PERCENT HABITAT TYPE (linear feet)

Hilton Creek is a small tributary located immediately downstream of Bradbury Dam that has intermittent or no flows in its lower reaches during the dry season. The estimated watershed area is approximately 4 square miles. About 2,980 feet of Hilton Creek is on U.S. Bureau of Reclamation (Reclamation) property, including the confluence with the Santa Ynez River. Figure 2-1 presents a schematic diagram of Hilton Creek, including a map of the recommended enhancement actions for Hilton Creek. Figure 2-2 provides a summary of Hilton Creek habitat quality and fish utilization attributes.

Habitat surveys in 1998 above the chute pool to the Reclamation property boundary (1,553 feet total) documented 61% riffle/cascade, 34% run, and 5% pool (SYRTAC 1998 data). The reach just above the bedrock chute (about 300 feet) is consecutive run/riffle habitat with little or no canopy cover. Above this open reach to the Highway 154 Culvert (about 2,400 feet total), habitat conditions are good to excellent with excellent riparian shading and cover. Pool habitat is greater than those in the lower Hilton (> 26%) and old growth sycamore dominate the vegetation providing dense canopy cover. Streamflows persist longer in this reach than farther downstream. Stream gradient increases to greater than 5% from the Reclamation property boundary to approximately .5 miles upstream of the Highway 154 Culvert. About 1,200 feet of this habitat is on Reclamation property. The Highway 154 Culvert is a complete passage barrier and is located about 4,200 feet upstream from the confluence and about 1,200 feet upstream from the Reclamation property boundary.

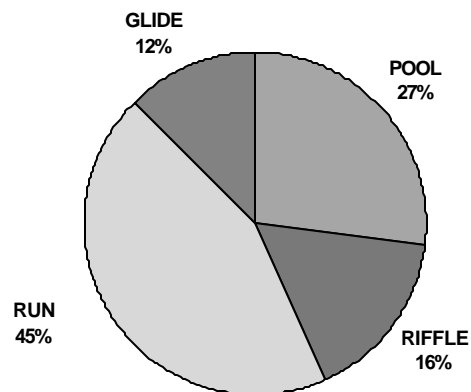
Pool	Riffle	Run	Glide
Quantity	5	3	5	1
Distance (ft)	192	115	315	88
Distance (%)	31.9	19.1	52.3	14.6
Avg Depth (ft)	1.5	0.36	0.61	0.38
Avg Max. Depth (ft)	2.6	0.85	1	0.8
Avg Instream Shelter (%)	25 to 50	75	25 to 75	75
Avg Canopy (%)	25 to 100	75 to 100	50 to 100	100
Dominant Shelter Components	Boulders, bedrock ledges, root masses; some undercut banks, sm. woody debris and aquatic vegetation	Root masses and boulders; some sm. & lg. woody debris, and terrestrial vegetation	Root masses, terrestrial vegetation, undercut banks, and terrestrial vegetation	Sm. woody debris, root masses, and terrestrial/aquatic vegetation

QUIOTA CREEK  
PERCENT HABITAT TYPE  
(linear feet)

A total of 602 linear feet of accessible Quiota Creek was habitat typed by the SYRTAC biologist, where habitat composition is 32% pool, 19% riffle, 52% run, and 15% glide. Refugio Road crosses Quiota Creek nine times starting with several crossings 1.3 to 1.6 miles from the mainstem Santa Ynez. In 1998, a survey was conducted from road crossings about 1.5 to 3 miles upstream from the confluence. Habitat conditions in this area are better than in the lower reach, particularly after the storms of 1998. Good canopy conditions provide shading within this section. Additionally, pool habitats have good depth and complexity of instream cover. Numerous undercut banks exist (particularly in pools) providing excellent rearing habitat. In contrast to several other tributaries, substrate is composed of larger size gravel, cobbles, and

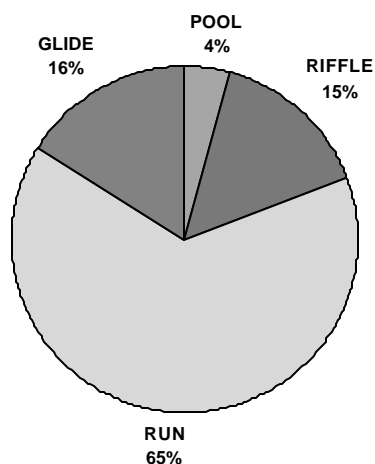
Pool	Riffle	Run	Glide
Quantity	14	34	42	15
Distance (ft)	670	2478	10620	2614
Distance (%)	4.1	15.1	64.8	16
Avg Depth (ft)	2.3	0.7	1	1.2
Avg Max. Depth (ft)	3.5	1.3	2	2.3
Avg Instream Shelter (%)	0 to 100	25 to 100	50 to 75	25 to 50
Avg Canopy (%)	0 to 50	0 to 75	0 to 50	0 to 50
Dominant Shelter Components	Aquatic vegetation (lower) and root masses, boulders, terrestrial vegetation, undercut banks (upper); sm. & lg. woody debris	Whitewater, aquatic vegetation (lower), boulders (upper); terrestrial vegetation	Aquatic vegetation (lower/upper) and boulders, terrestrial vegetation (upper); lg. woody debris and root masses (upper)	Aquatic vegetation (lower/upper), terrestrial vegetation (upper); undercut banks/bedrock ledges (upper) and sm. woody debris (upper)

**NOJOQUI CREEK  
PERCENT HABITAT TYPE  
(linear feet)**

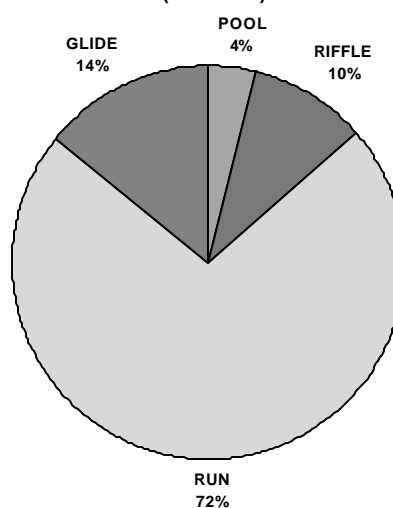
**Figure 2-7 Summary of Salsipuedes Creek and El Jaro Creek Habitat Attributes**

**SALSIPUEDES & EL JARO CREEKS  
PERCENT HABITAT TYPE  
(linear feet)**

Substrate conditions varied by habitat in 1996, with silty conditions generally throughout lower Salsipuedes Creek. Pools were dominated by fine sediments, and sub-dominated by bedrock and gravels. Riffles were dominated by small cobbles, and sub-dominated by gravels and large cobbles. Run habitats were dominated by gravels and fine sediments, and sub-dominated by small cobbles.

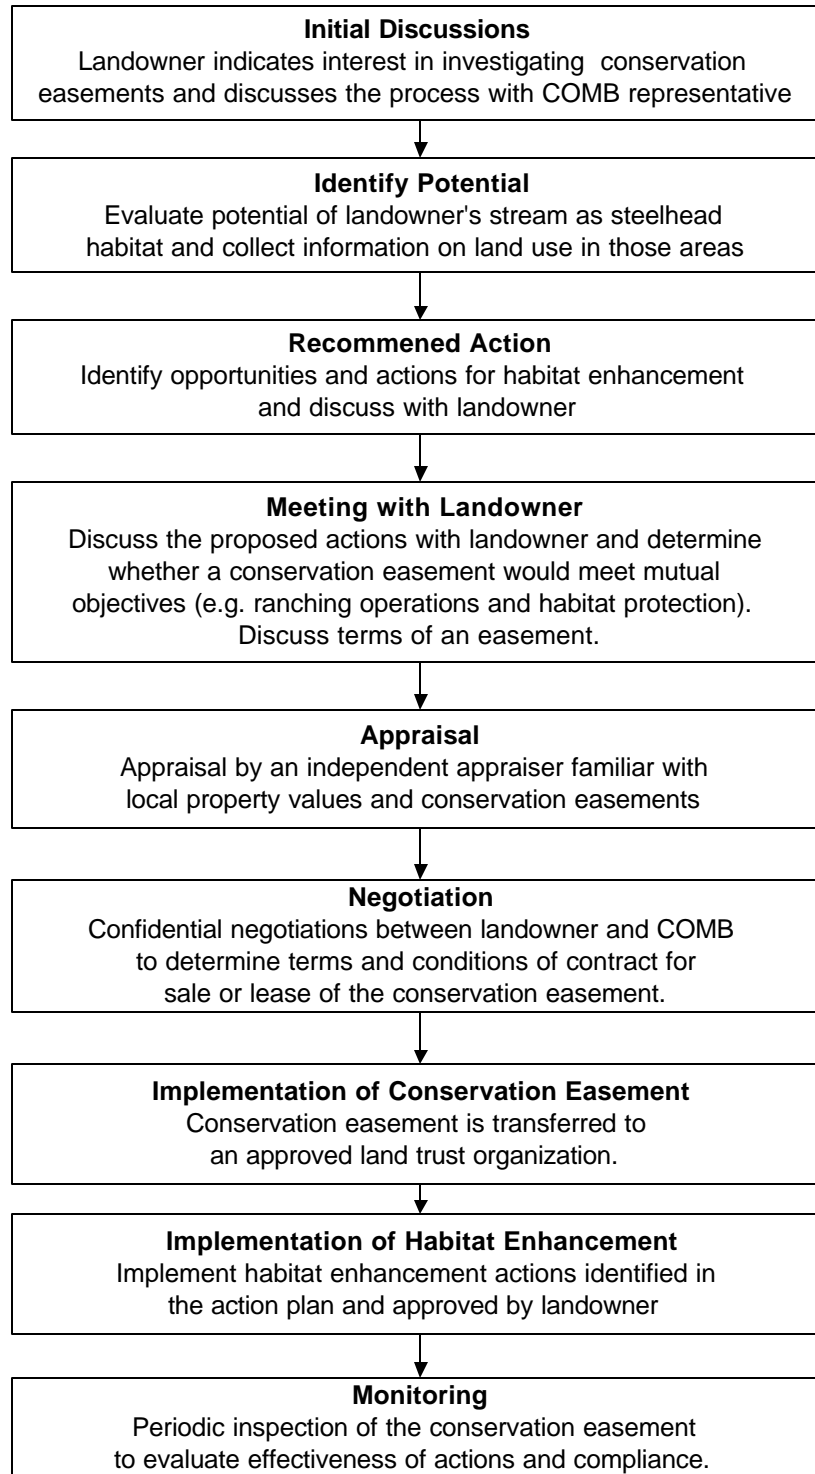
**Figure 3-1 Conservation Easement Process**

## CONSERVATION EASEMENT PROCESS

The general process for establishing conservation easements starts with discussions between the landowner and COMB (Figure 3-1). Potential actions and evaluation of benefits, such as collecting information to evaluate the stream as steelhead habitat, and assessing opportunities to improve habitat, will be discussed with the landowner. An independent appraiser familiar with assessing property values for conservation easements

will do an appraisal. The landowner and COMB determine the terms and conditions for sale or lease of the conservation easement. After the easement is established, the Adaptive Management Committee would then implement the habitat enhancement actions identified and monitor improvements to appropriately manage the conservation easement. Each step in this process is completely voluntary, and the landowner reserves the right to bow out at any point up to the purchase of the easement.
